No. 754

AN INVESTIGATION OF THE PREVENTION OF ICE ON  
THE AIRPLANE WINDSHIELD

By Lewis A. Rodert  
Langley Memorial Aeronautical Laboratory

Washington  
March 1940

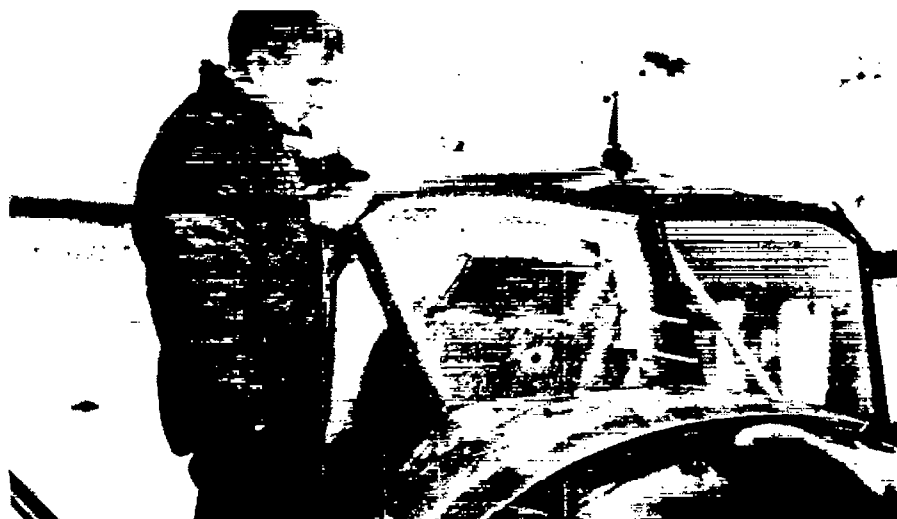
Figure 11.- The electrically heated flight test model after flights during which ice was both prevented and removed on the test panel. Note freedom from overhanging ice at the edges.

The results of the flight tests with the electrically heated model are given in table II. Figure 11 shows the flight model after tests during which the formation of ice over the protected panel was prevented. The ice was kept from overhanging the protected region, as it had during the tunnel tests, by heating the rim of the protected area. The protrusion of the rim of the test panel about 1/16 inch from the surrounding windshield may also have aided in the prevention of the overhanging of ice from the unprotected areas. Vision through the double-glass panes and through the ethylene-glycol filler was satisfactory, being about the same as through a similar thickness of plate glass.
